## *Hashing Out Flashings*

IAQ IQ, Spring 2017

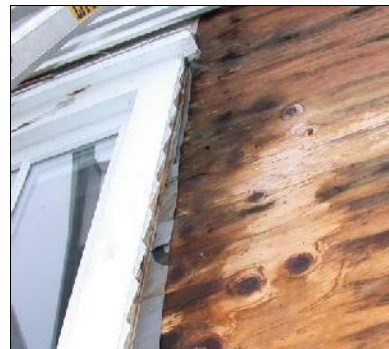
Most often but not always, I would find portions of the siding and/or trim that had been removed to reveal severe decay at the OSB or plywood sheathing. Generally, the damage was around windows or doors or at the corners of buildings.

*Decayed sheathing behind clapboards*  
May Indoor Air Investigations LLC

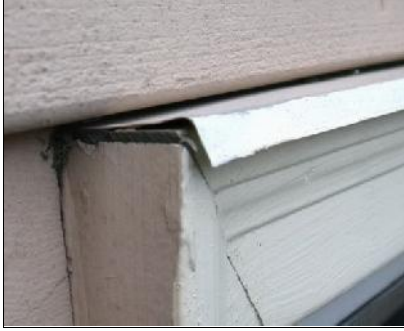
The most common error that I observed was the improper installation of window-cap and door-cap flashings. These flashings installed above the horizontal trim casings are supposed to shed water to the front of the flashing and away from the trim board. In over 90% of the installations, the portion of the flashing over the trim board was bent upward at the drip end, thus preventing water from dripping off the flashing.

*Cap flashing with improper pitch and open joint*  
May Indoor Air Investigations LLC

Instead the water would gather at the back of the flashing, and some of the water would soak into the back of the clapboard in contact with the flashing (often causing paint peeling). Most of the water would then flow to the ends of the flashing, where it would flow down joints such as the casing joints and the joints between the butt ends of the clapboards and the vertical casing trim surrounding the window or door.

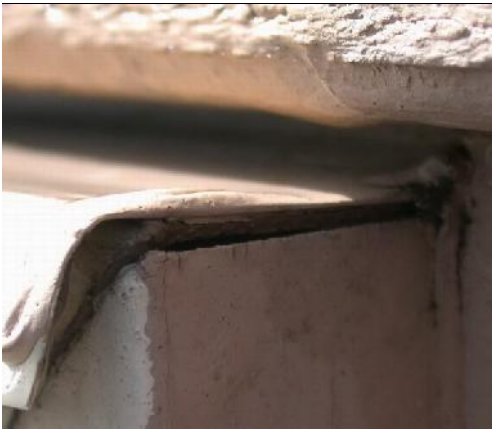
My procedure for the investigation was pretty much always the same. I would fill one of my squirt bottles with water and put some water on top of the flashing to demonstrate that the water was being trapped at the back of the flashing and then flowing down vulnerable trim and siding joints.

*Test water entering miter joint*  
May Indoor Air Investigations LLC

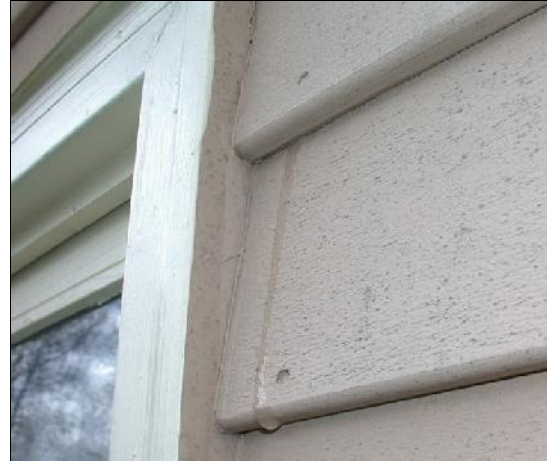
After I had added about a pint of water, often water would start pour out of clapboard joints, indicating water entry behind the siding.

Generally, the contractor present would then remove some of the window or door trim and siding and find (to his or her great consternation) that water had entered the space behind the siding and or trim.

*Test water exiting clapboard*  
May Indoor Air Investigations LLC

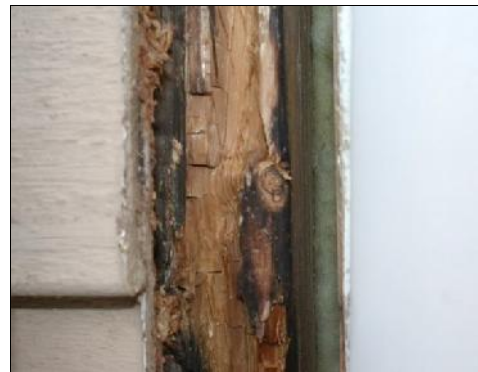
*Stud decay at behind casing*  
May Indoor Air Investigations LLC

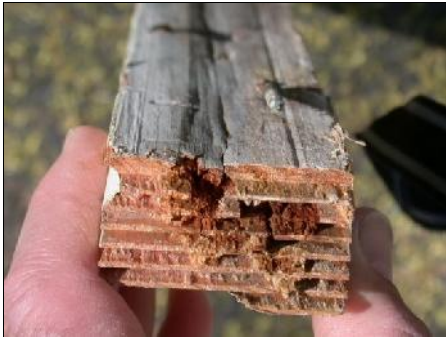
*Decayed vertical casing after removal*  
May Indoor Air Investigations LLC

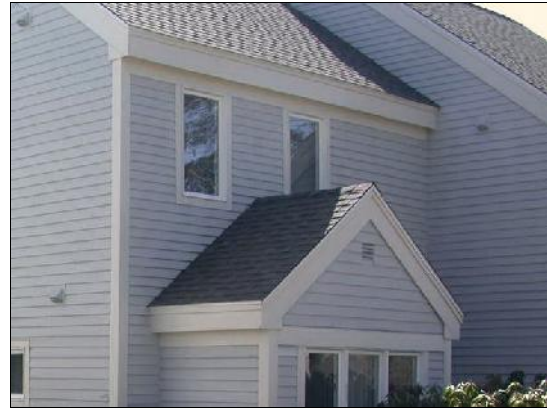
Another construction weak point is at the intersection between the siding of a second floor and a first-floor roof.

*Large volume of roof water flows from upper gable onto lower gables*  
May Indoor Air Investigations LLC

Unless the intersection is literally waterproof, a kick-out flashing is usually needed; for cement board siding, installation of a kick-out flashing is required.

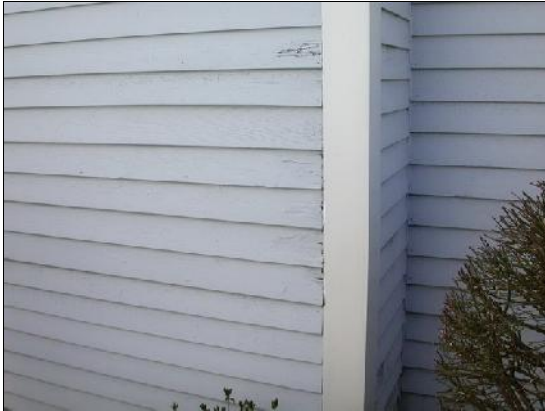
owner's bedroom at the first-floor. There was some siding and trim decay at an exterior corner of the bedroom.

*Visible siding decay at exterior corner*  
May Indoor Air Investigations LLC

There was no gutter at the upper rear-roof gable, and copious amounts of water flowed from the upper roof onto the surfaces of a lower roof, where there was no kick-out flashing.

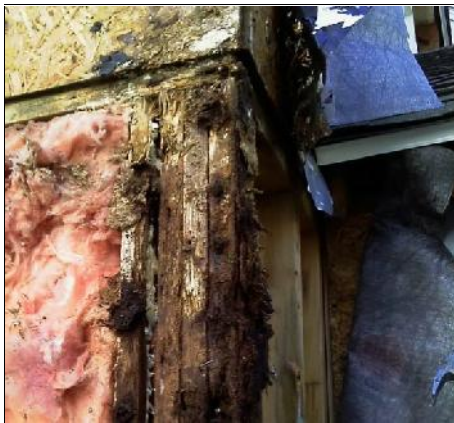
Water must have been flowing into the space behind the clapboards since the day of construction. The minor decay that was visible at the clapboard ends was nothing as compared to the sheathing and framing decay that was revealed after the siding was removed.

*Decayed sheathing and corner post*  
May Indoor Air Investigations LLC

Had there been a kick-out flashing present, it is unlikely that this damage would have occurred. The musty odor at the bedroom interior was due to the microbial activity surrounding the wall

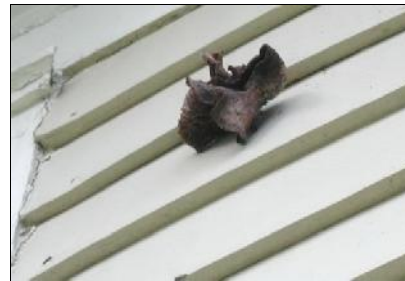
On two occasions I actually found mushrooms growing out of the siding on a home. In both cases there was a flashing leak at the roof edge above.

*Mushroom on hardboard siding*  
May Indoor Air Investigations LLC

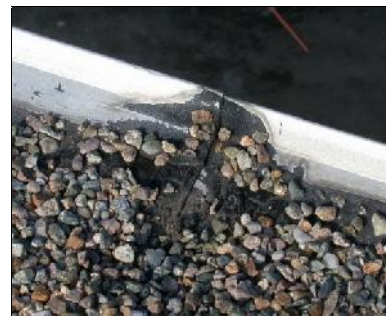
*Gap in roof flashing*  
May Indoor Air Investigations LLC

If you see a gap like this in a roof flashing, you can easily test to see if it is a source of water entry. Place a drop of water on the crack; if the water is sucked in, place another drop. If several drops of water enter, the opening is likely to be a leak source. You don't need to use a hose to see if a gap such as this is a problem. A small amount of water entry is sufficient proof for a failure and the need for repair.
