IAQ IQ, Fall 2016

Cracks

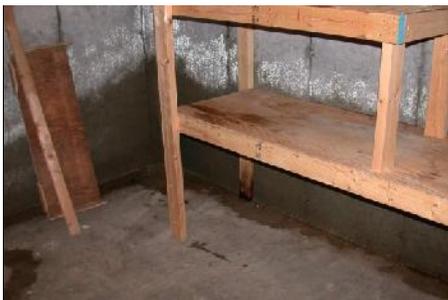
Moisture stains and efflorescence point to basement water intrusion

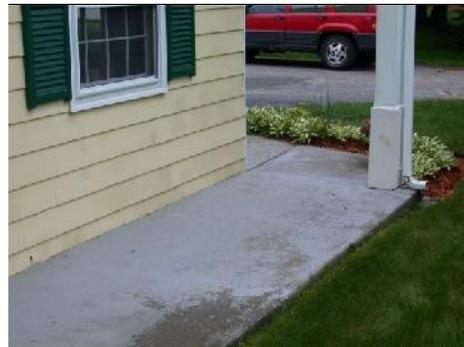
*Woops! What's wrong with this picture?
Gutter-system maintenance is important!*

Splash blocks can be knocked out of place, and dry wells can become blocked over time. I prefer to see solid, 4" PVC piping buried a few inches below the soil and extended to daylight at the edge of a landscape furrow or downhill from the building. The downspouts can then be inserted into this piping to direct water away from the foundation wall.

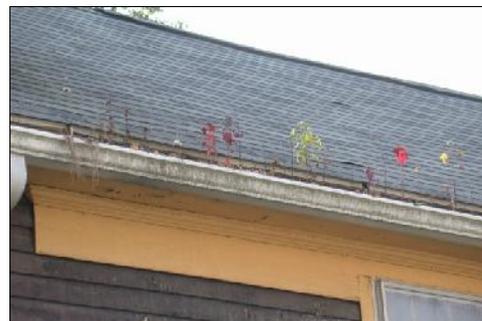
A GG: Gutter Garden

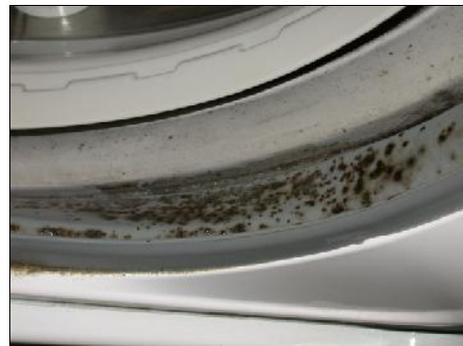
Washing machine with mold growth
May Indoor Air Investigations LLC

In the first single family that I owned, the washing machine was on the third floor. The house had balloon-framing, and once the machine was seriously unbalanced and thus vibrated energetically for a moment or two before I could rush up the stairs to turn the appliance off. Several cracks appeared in the walls near and under the machine shortly after this event. (Washing machines can also become contaminated with mold growth.)
