IAQ IQ Winter, 2016-2017
Case Studies of Building Odors
©2017 Jeffrey C. May

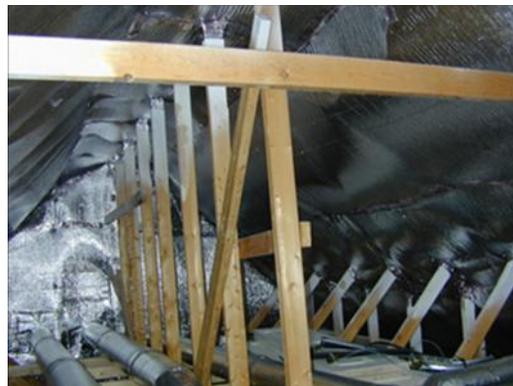
SPF in attic, covered with foil to prevent off-gassing
May Indoor Air Investigations LLC

Unfortunately, such an odor can diffuse through drywall. He could cover the ceiling drywall with aluminum foil (which prevents off-gassing) and then install a new drywall ceiling over that. A more dramatic solution would be to remove the ceiling altogether, paint the foam with shellac, cover it with aluminum foil, and reinstall the ceiling. He would still have to be careful, though, to avoid any unnecessary ceiling penetrations in the room. The most drastic step, of course, would be removal of the insulation.

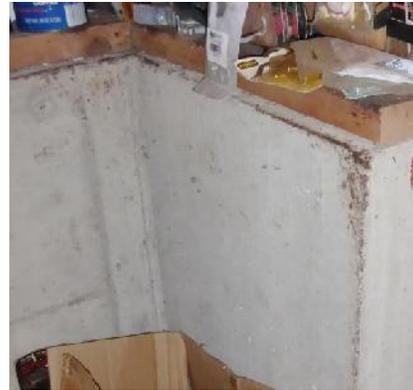
Rust-colored mouse-urine stains on concrete edges
May Indoor Air Investigations LLC

As part of the basement remediation in this property, the insulation had to be removed and exposed surfaces cleaned and sealed. Any surfaces that contained mouse droppings or mouse urine stains had to be disinfected as part of the remediation process.

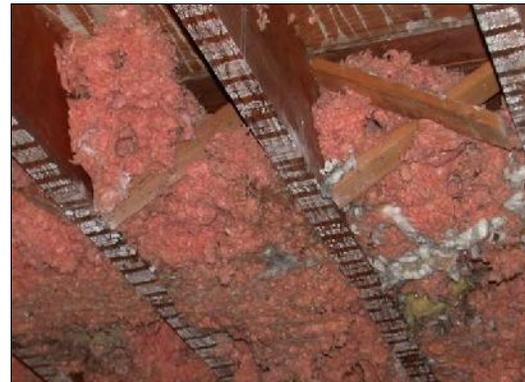
Circular mouse burrows in garage insulation
May Indoor Air Investigations LLC

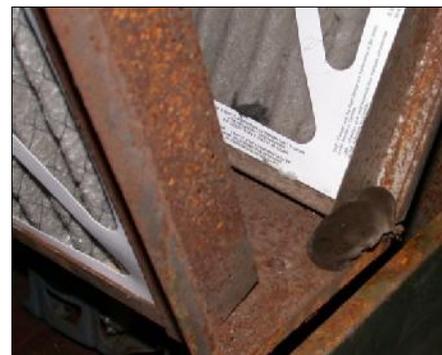
And shrews, too, had moved in, following one of their favorite prey: mice. Shrews, like skunks, exude an odor that many have described as musty. In addition, they defecate and urinate in big piles that become mold-infested.

Dead shrew in air handler
May Indoor Air Investigations LLC

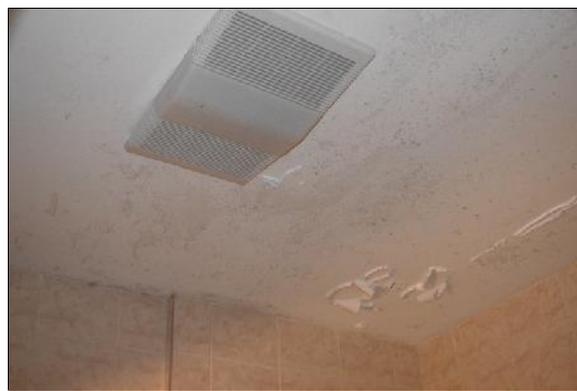
It's not unusual to see surface mold growth in a bathroom. People don't operate the exhaust fan long enough after showering; in addition, an oscillating fan helps move the air and speeds drying of surfaces, but people rarely use such a fan.

Bathroom ceiling with peeling paint and spots of mold growth

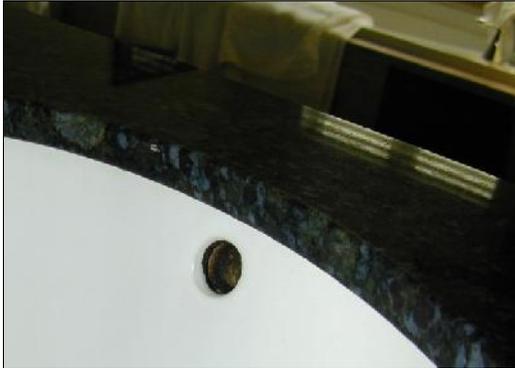
The odor source was simple: microbial growth in the sink overflow. All the man had to do was to pour a dilute bleach solution down the overflow, scrub as much of the accessible area of the overflow that he could reach with an old

Microbial growth in sink overflow
May Indoor Air Investigations LLC

toothbrush, and then rinse the overflow with plain water.
