## *Hashing Out Flashings*

IAQ IQ, Spring 2017

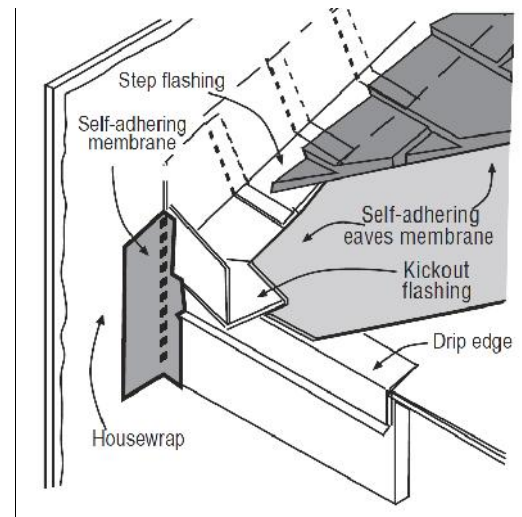
Unless the intersection is literally waterproof, a kick-out flashing is usually needed; for cement board siding, installation of a kick-out flashing is required.

Installation instructions for Hardiplank siding  
[https://web.mail.comcast.net/service/home/~/?auth=c&o&loc=en\\_US&id=482746&part=2](https://web.mail.comcast.net/service/home/~/?auth=c&o&loc=en_US&id=482746&part=2)
